DEVELOPMENT OF REPAIR PROCESSES  
AND SOURCES FOR C/KC-135 AIRCRAFT  
WINDOWS/WINDSHIELDS

RICHARD J. OLSON

BATTELLE  
505 KING AVENUE  
COLUMBUS, OH 43201

SEPTEMBER 1994

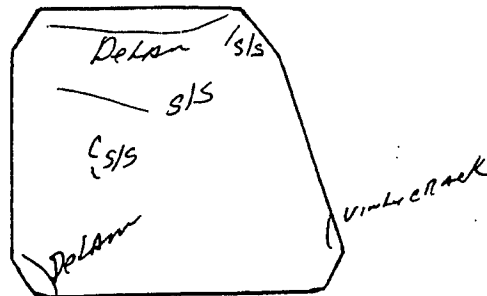
Delam as marked  
Surface SCR, as marked  
Viny Crack as marked

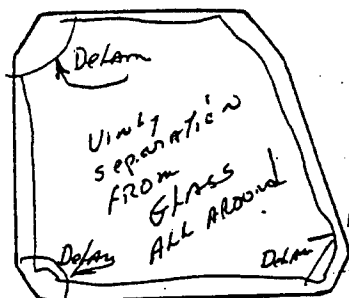
Vinyl separation from glass edge ALL AROUND unit inside

Delam AROUND unit in corner unit has surface scr. Remover Between ply.
